2012 University Turbine Systems Research (UTSR)
Industrial Fellowship Program

Final Report

Center Electrode Life Test of an Iridium Alloy
&
Weld Matrix Database

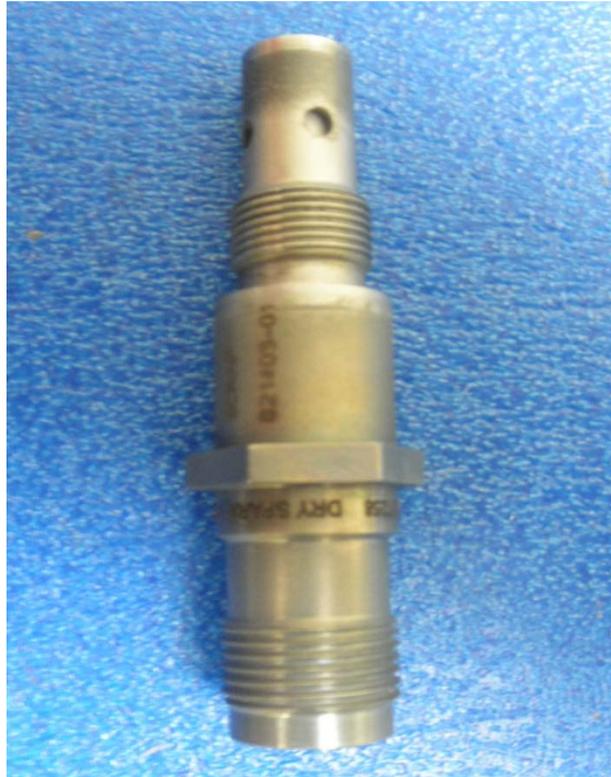
Figure 1. Igniter Housing.

The stock igniter has a center electrode made of Inconel 600 with a diameter of 0.125". A vertical mill was used to remove a portion of the center electrode. Then, a 0.95" diameter drill was used to drill into what was remaining of the center electrode. Next, a taper was applied to the Ir alloy rod, and the rod was press fitted into the 0.95" hole. The thought behind this was after the first few sparks, the gap between the Ir alloy rod and the Inconel 600 center electrode would arc and weld together. The material for the outer electrode is also Inconel 600. Figures 1 and 2 show a plug that was used for the test.

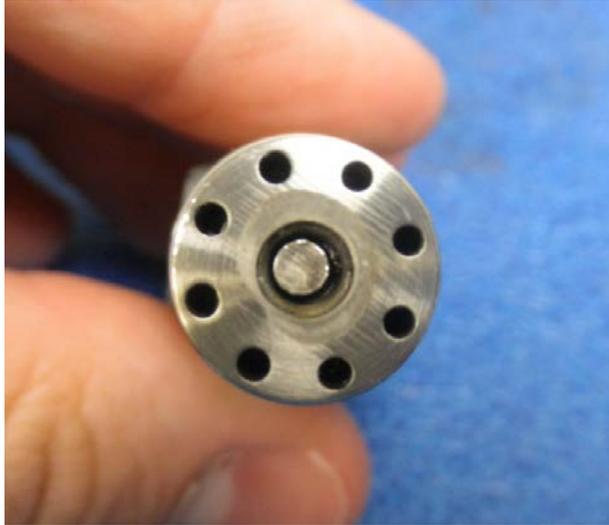
Figure 2. Igniter Tip with Ir Alloy Electrode.

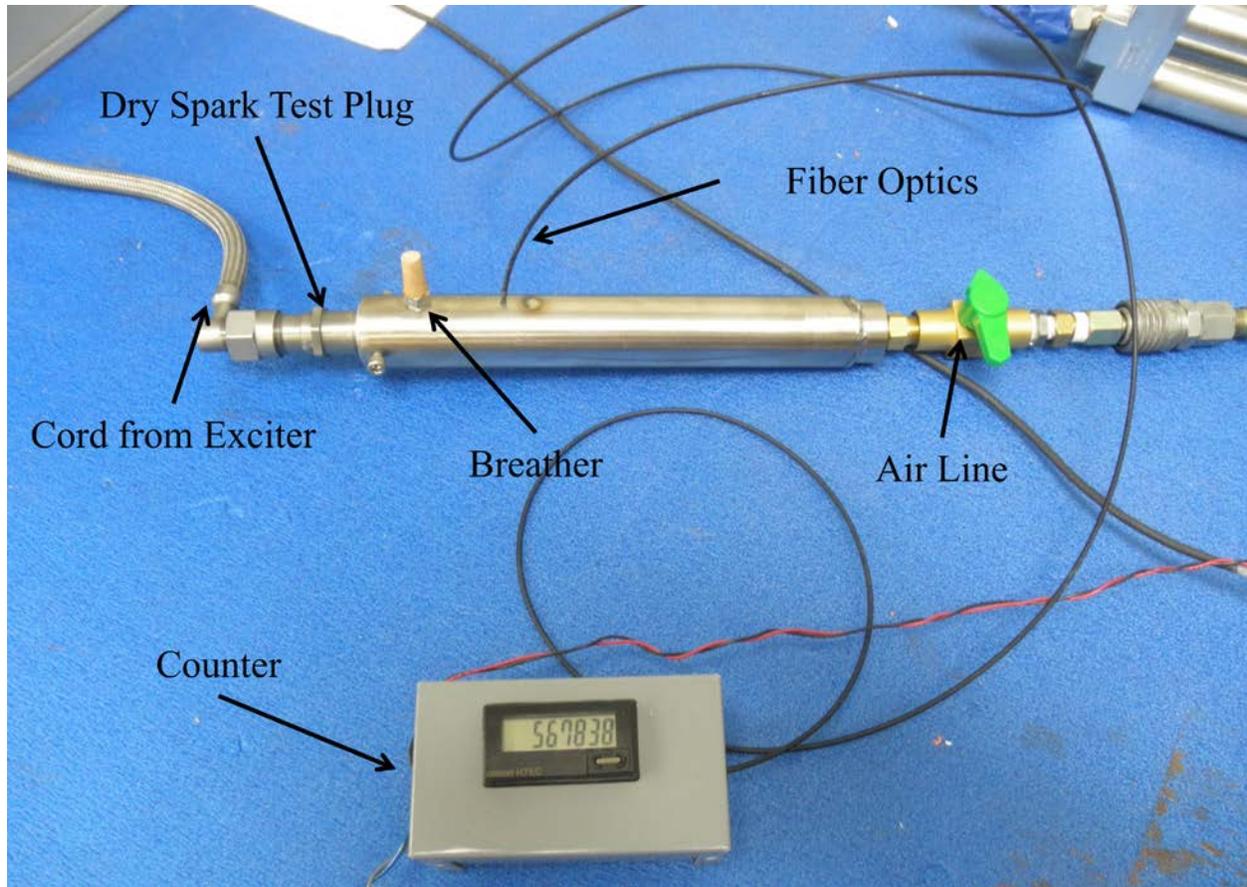
In order to obtain an accurate depiction of the life cycle of the Ir alloy, we needed to have an accurate count of the number of times the igniter sparked. Therefore, the igniter was threaded into a stainless steel cylinder. A small hole was drilled in the side wall of the cylinder, and a fiber optic cable was inserted into the hole. The fiber optic cable was connected to a counter that kept count of the number of sparks or flashes that occurred in the cylinder. The counter box was powered by an external power supply. In order to help keep the igniter cool and to blow away any possible debris/deposits, the other end of the cylinder supplied compressed air. A breather was installed on the side wall of the cylinder to help relieve pressure. The sparks were controlled by an exciter box that contained all the necessary components to produce sparks at a set interval and intensity. Figure 3 shows the setup for the dry spark test.

Figure 3. Dry Test Setup.

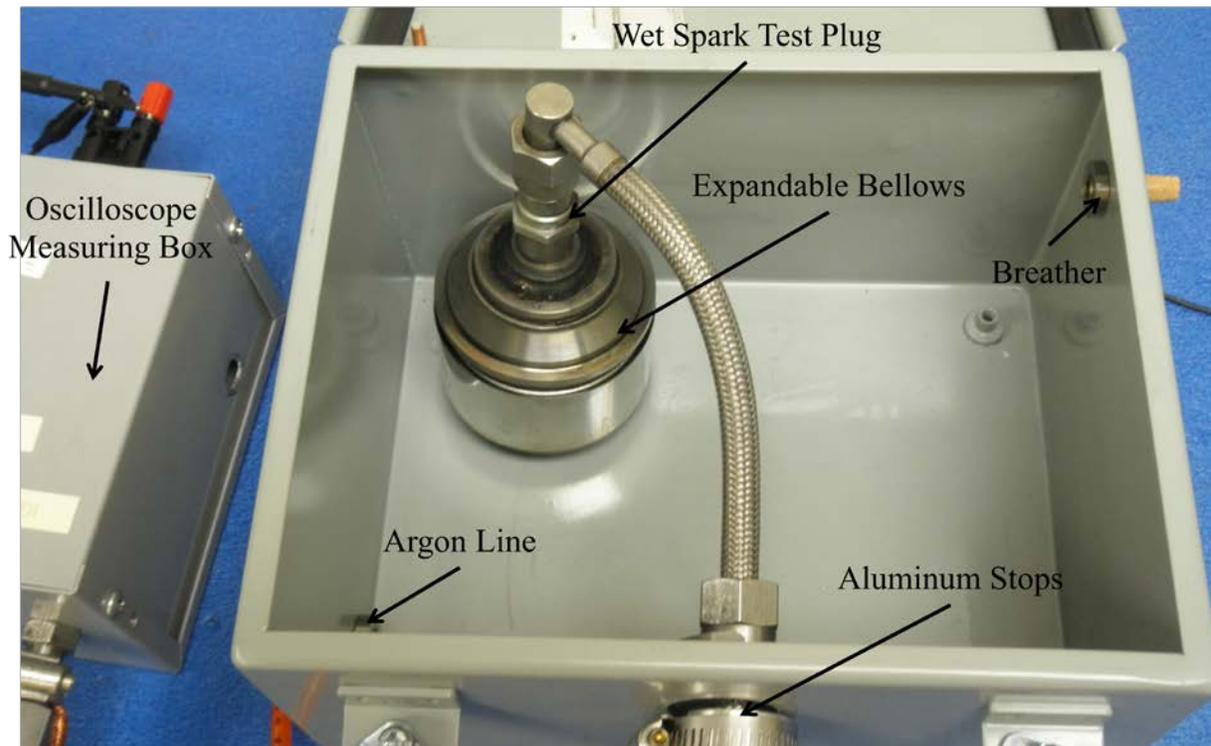
The wet spark test apparatus used for this testing differed from previous wet spark test setups. Instead of dripping fuel onto the igniter at a controlled rate, the igniter tip was fully submerged in fuel. A special container made with an expandable bellows was fabricated to hold the fuel and also to keep the igniter upright. The expandable bellows allowed the sealed container to adjust to the rises in temperature and pressure of the sparks. In the extremely unlikely that a spark would actually cause an ignition of the fuel, the bellows needed to be shielded in argon gas. To contain the argon gas, as well as protect people and equipment from harm, the bellows and igniter were placed in an explosion rated steel enclosure. A breather was outfitted to the steel enclosure to depressurize the internal volume. Figure 4 shows the inside of the steel enclosure while Figure 5 is an outside view of the enclosure.

Figure 4. Wet Spark Setup, Inside View.

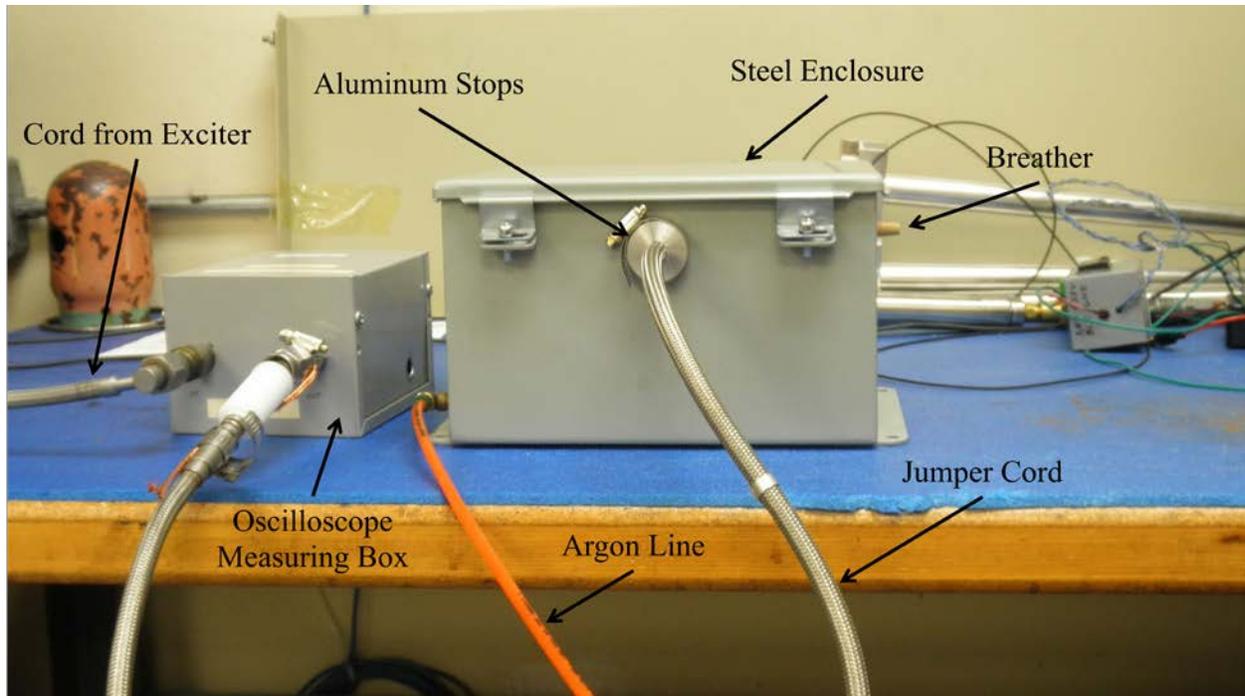
Figure 5. Wet Spark Setup, Outside View.

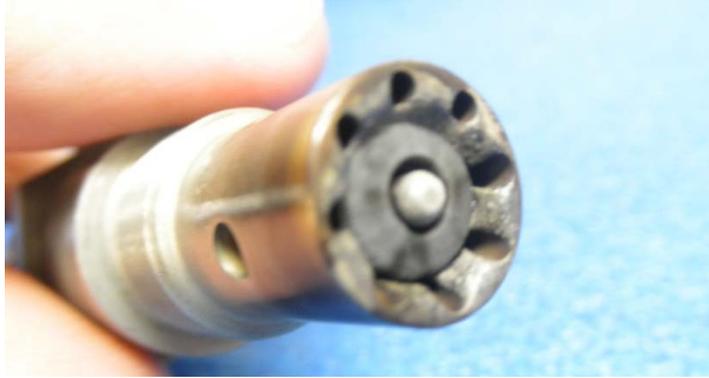
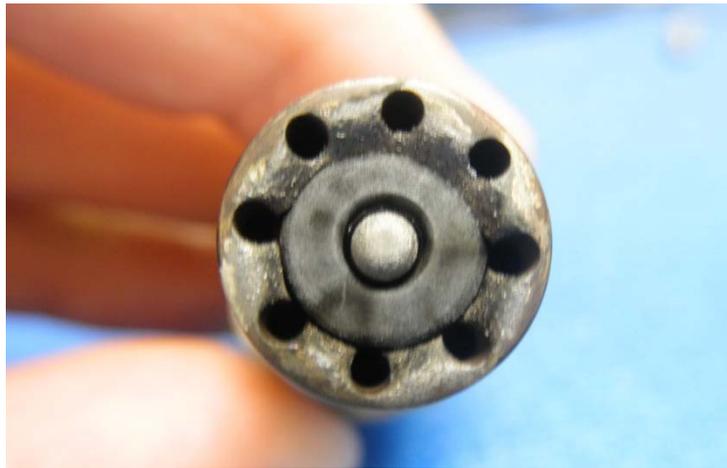
When the test started, the instructions stated to end the test when the igniter fails to spark. After analyzing the igniter at 567,838 sparks, it was decided to end the test. The igniter had greatly exceeded its required sparking life. Figures 6 and 7 are different views of the igniter tip at the end of the spark test. The majority of the material removed came from the outer electrode, which is comprised of Inconel 600. The center electrode had rounded edges. Instead of being a cylinder, it was more of a hemisphere on top of a cylinder.

Figure 6. Dry Spark Tip, End of Test.

Figure 7. Alternate View of Dry Spark Tip, End of Test.

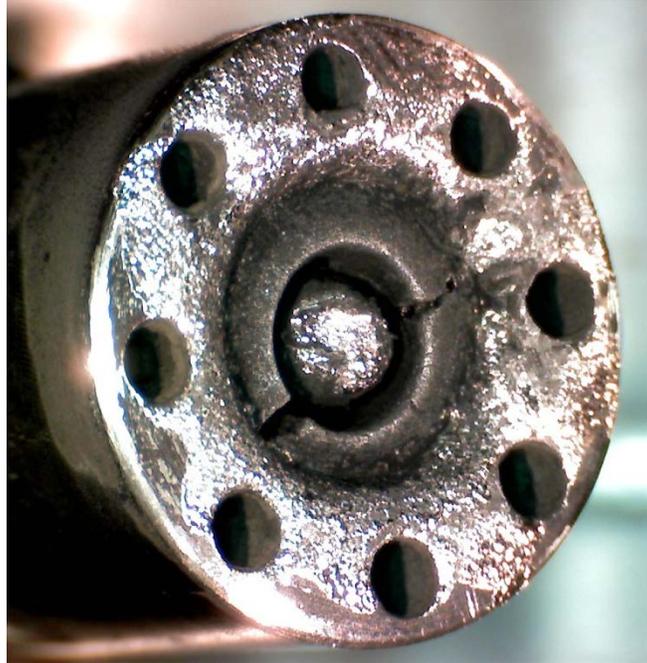
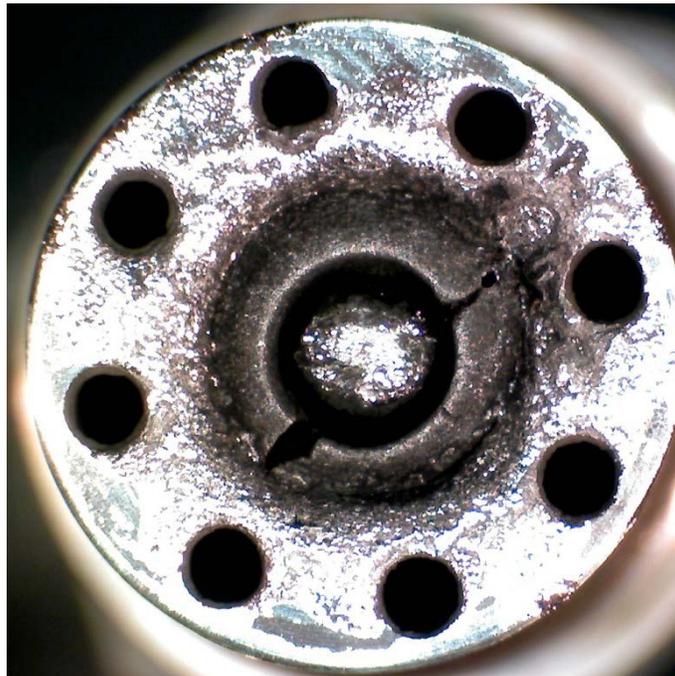
As with the dry spark test, this test was supposed to end when the igniter failed to spark. Nobody expected the test to last longer than 100,000 sparks. Therefore, the test was ended at the end of the day, when the count was at 126,028 sparks. The erosion characteristics were much different than that of the dry spark test. The center electrode was rounded, as in the dry test, but the electrode had eroded down to the insulation. There was much less erosion on the outer electrode when compared to the dry test. There was also a large crack in the insulation. It appears that the sparks would travel through the crack to the outer electrode, as there is a noticeable amount of material missing from the outer electrode at that location. Possible reasons for the crack include but are not limited to: high temperature and pressure within the test apparatus, damage from manufacturing, cracks in the microstructure that propagated during the test, etc. The results from the wet spark test can be seen in Figures 8 and 9.

Figure 8. Wet Spark Tip, End of Test.

Figure 9. Alternate View of Wet Spark Tip, End of Test.

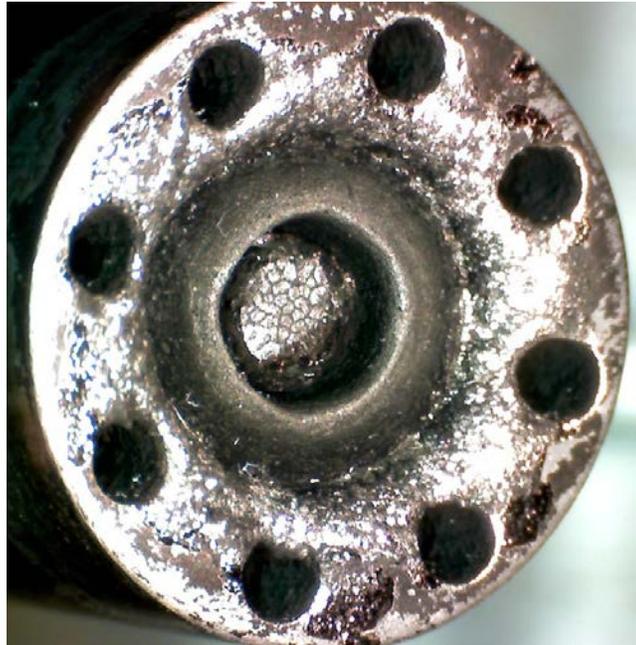
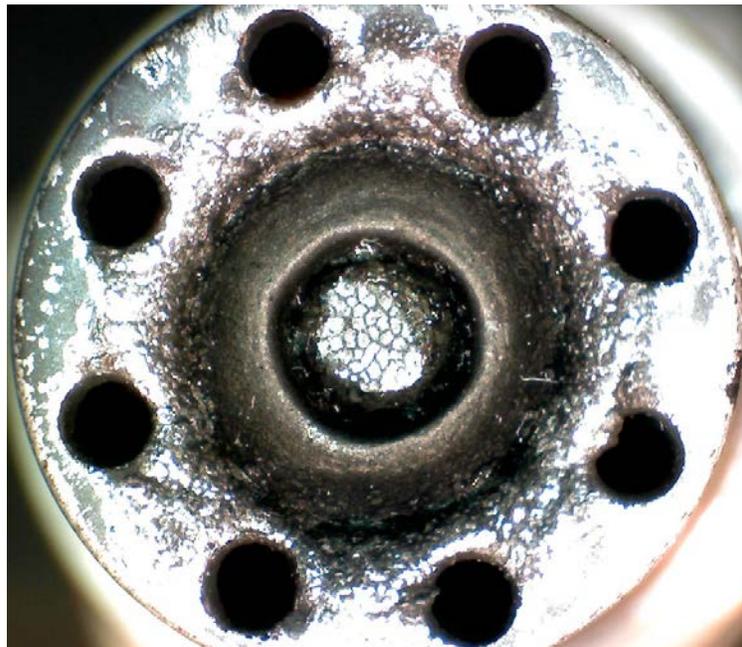
indication of this was that the current was falling throughout the test. After 142,254 sparks, the test was ended. The erosion pattern was similar to the alloy wet test, with a few differences. The center electrode was not rounded at the tip like in the other tests, but was flat on top. Also, the center electrode was eroded to a point below the insulation. The erosion on the outer electrode was similar to the other wet test. Figures 10 and 11 show the igniter tip at the end of the test.

Figure 10. Baseline Wet Spark Tip, End of Test.

Figure 11. Alternate View of Baseline Wet Spark Tip, End of Test.

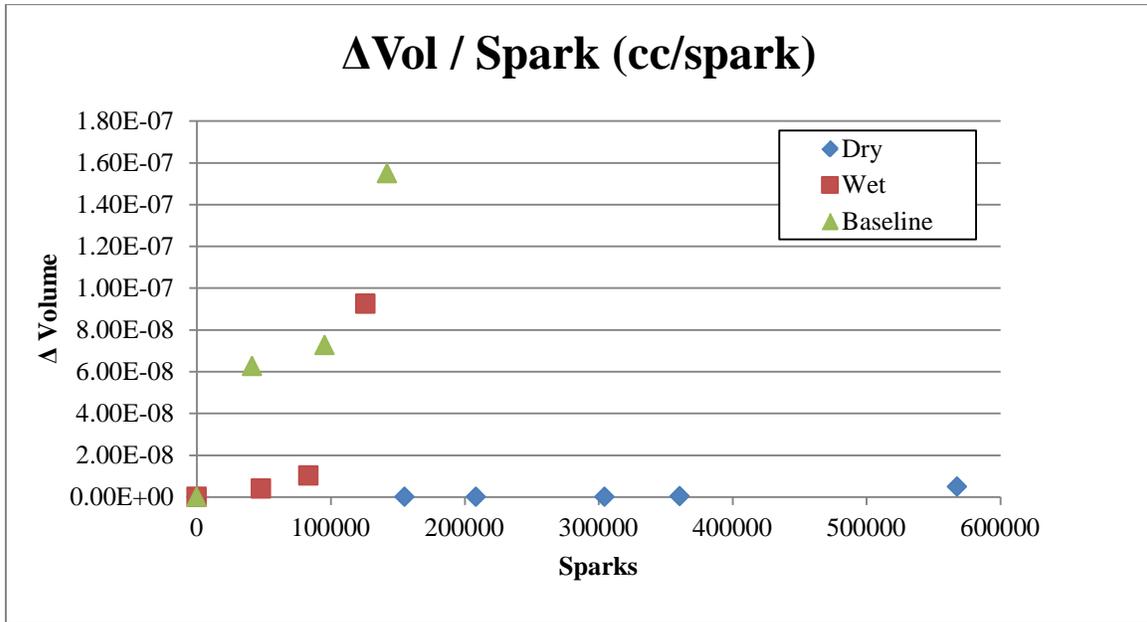
The data that was collected during the tests were compiled into an Excel spreadsheet. The volume loss was calculated for each test, assuming various geometries for the material lost. Then, using the densities of the various materials, a mass loss was calculated. All data is for the center electrode only. Figure 12 shows the change in volume, in cubic centimeters, per spark. The baseline wet test is an order of magnitude greater than the alloy wet test. Figure 13 displays the change in mass, in grams, per spark. At the end of the test, the wet alloy actually loses more mass per spark than the baseline, due to the higher density of the alloy. A graph of each test and the total volume loss, in cubic centimeters, at 140,000 sparks can be seen in Figure 14.

Figure 12. Change in Volume per Spark.

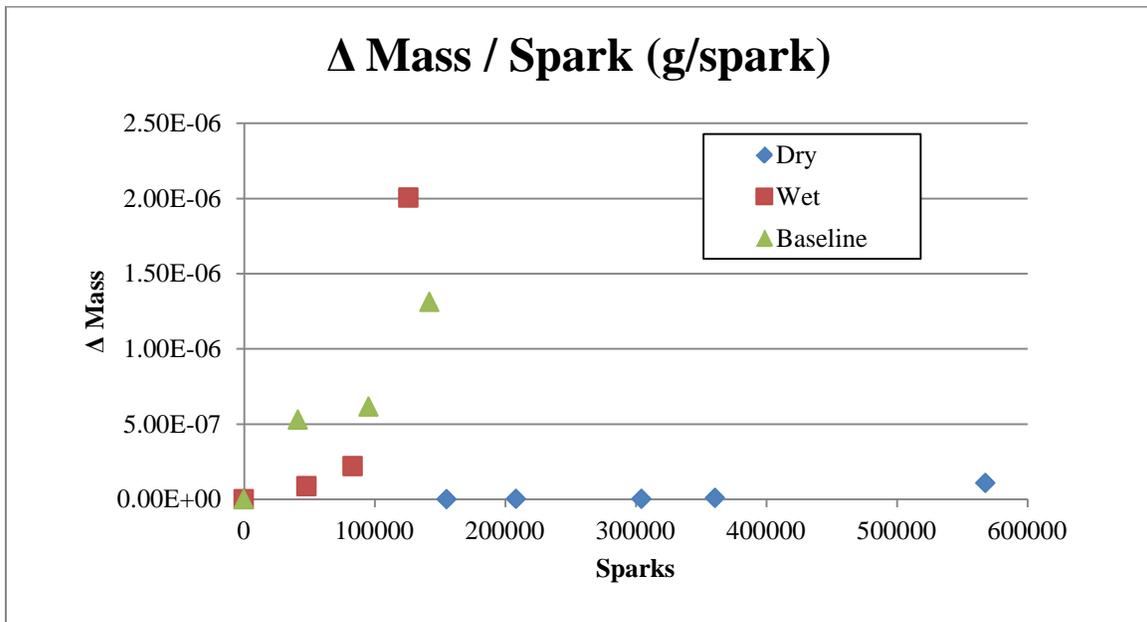
Figure 13. Change in Mass per Spark.

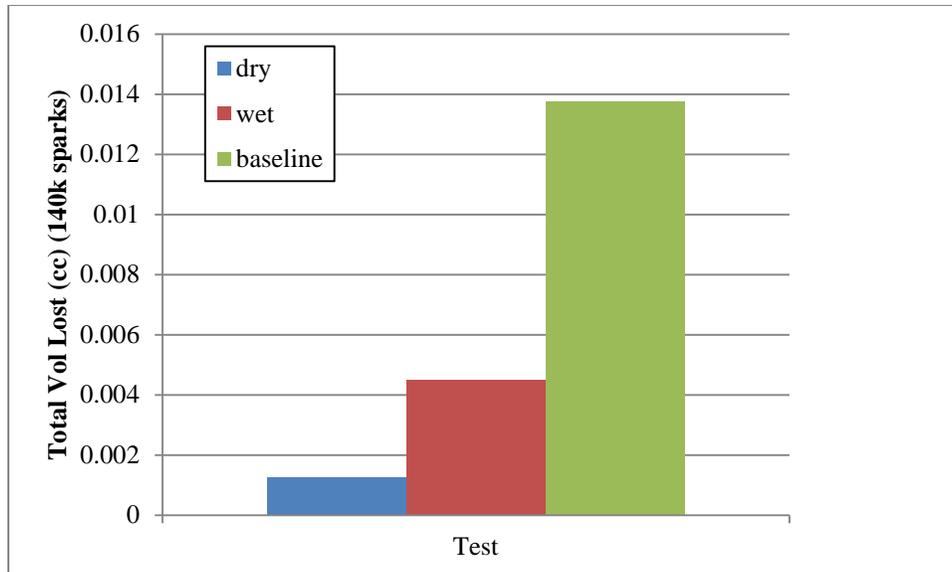
Figure 14. Total Volume Lost at 140,000 Sparks.

electrode made of the alloy performs better than the current center electrode. The current center electrode has almost three times the volume loss as the center electrode made up of the alloy. Previously, it was thought that the wear rate was only dependant on the material of the electrodes. Now, however, it appears that the wear rate is a function of both the material and the geometry of the electrode.
