# The Corrosion of Electrocoated Steel Studied by a Combination of Accelerated Exposure and Electrochemical Methods

Pedro Atz Dick<sup>1</sup>

<sup>1</sup> PPG Industries

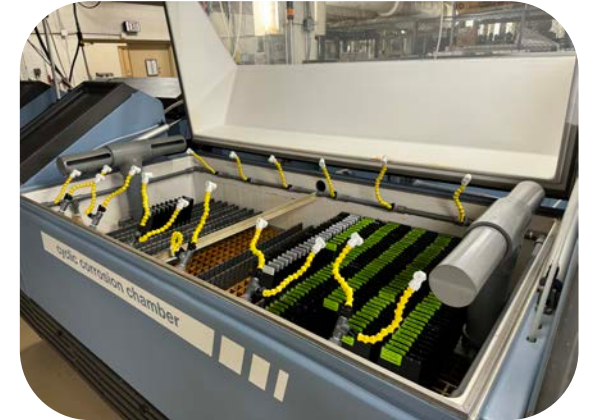
## Accelerated corrosion tests

- Use elevated RH, corrosive solutions, elevated T etc. to accelerate corrosion
- Static (B117, HSW) or cyclic (SAE J2334, VDA 233-102...)
- Typical analysis:  
Assessment of cosmetic corrosion in 1 or 2 dimensions
