# The Use of Corrosion and Environmental Sensors in Automotive Test Environments

Ford Research & Innovation Center

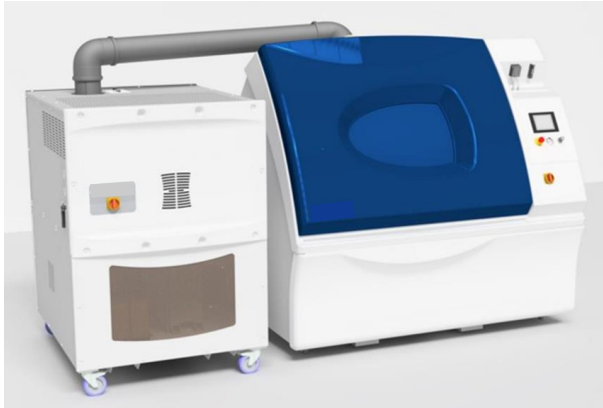
View of cyclic corrosion chamber

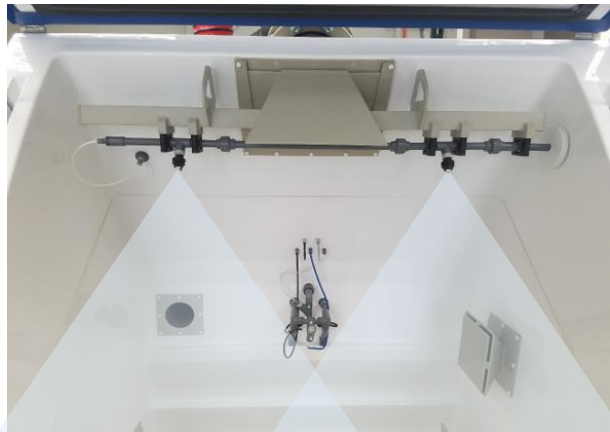
Inside view of cyclic corrosion chamber

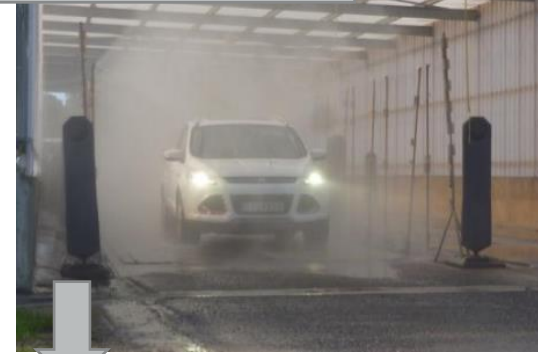
Salt spray passage

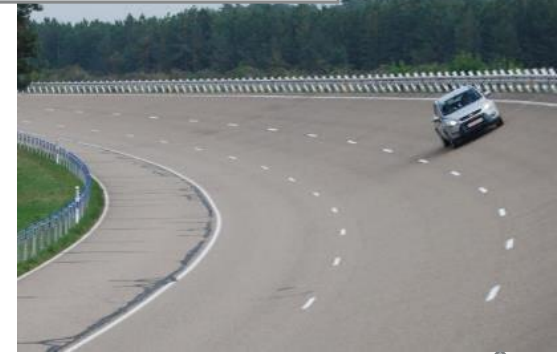
High speed track

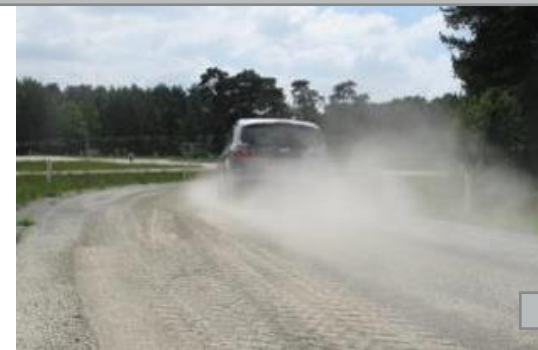
Dust and abrasion from gravel

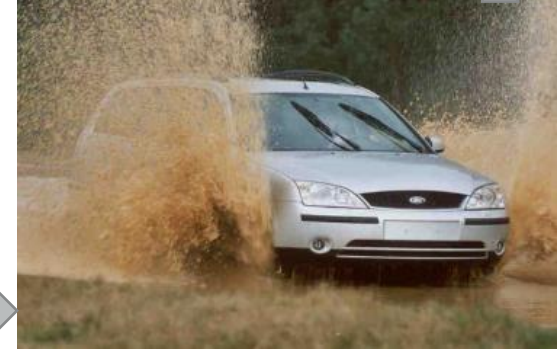
Mud trench

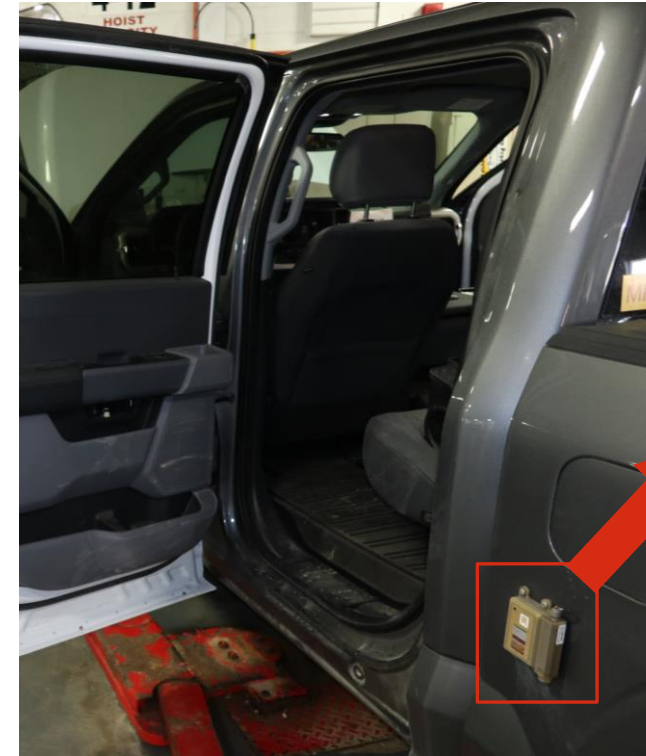
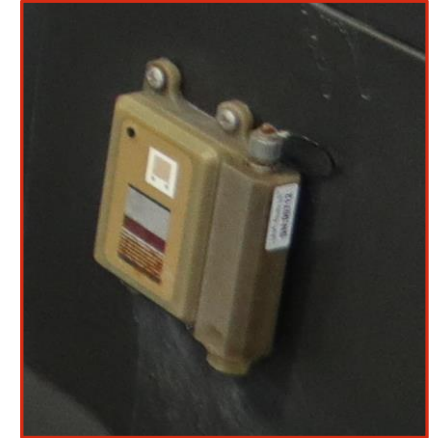
Externally mounted an Acuity LS sensor on a F-150 truck used for on-vehicle at proving ground corrosion test

1. Method: R-343 test
2. Duration of data recording: 6 weeks
3. Solution: 0.5wt% NaCl for passage and 1.0%NaCl for wading bath
