Aircraft Bonded Repair of Metallic Structures

Southwest Research Institute® (SwRI®) has designed, analyzed, tested and installed bonded repairs for various aircraft since the mid-1990s. SwRI has designed both metallic and composite bonded repairs for wing skin planks, pressurized transport fuselage structures, and complex three-dimensional fighter bulkheads. Software design and analysis capabilities include Pro/ENGINEER®, UGS® NX/NASTRAN, Graphite, MSC. NASTRAN®, ABAQUS®, StressCheck® and CRAS.

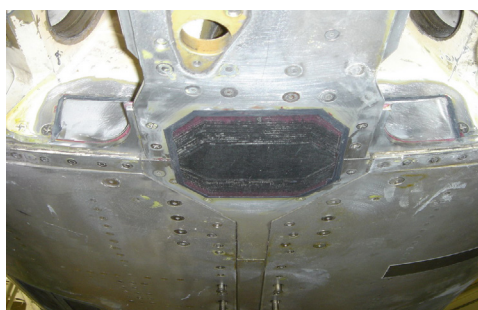
D015707

Prototype installation of F-16 bulkhead bonded repair on an inservice aircraft
