CREVICE CORROSION OF ALUMINUM ENCLOSURES AT SEALING INTERFACES

ULLRICH HAUS

THE ISSUE: ELECTRONIC MODULES FAIL IN CORROSION TESTING DUE TO EXCESSIVE CREVICE CORROSION

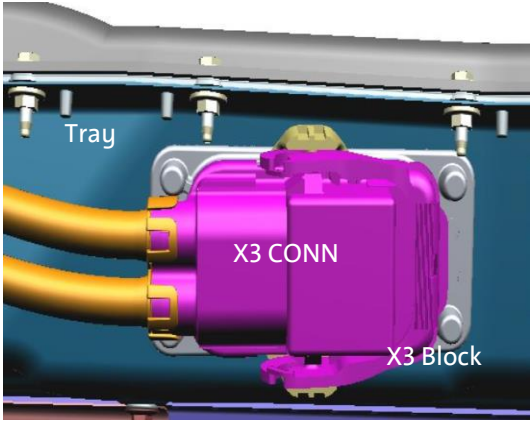
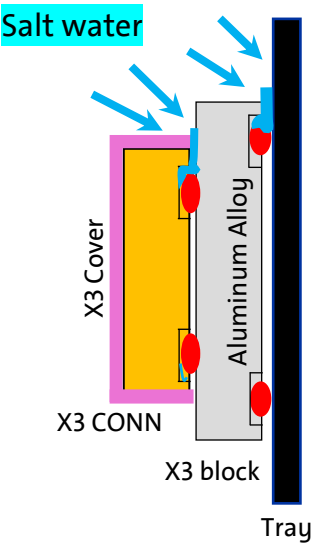
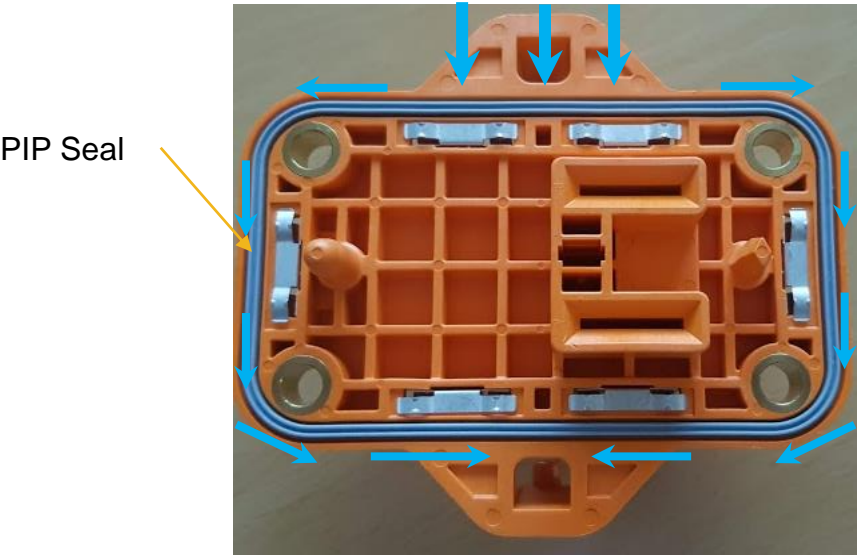
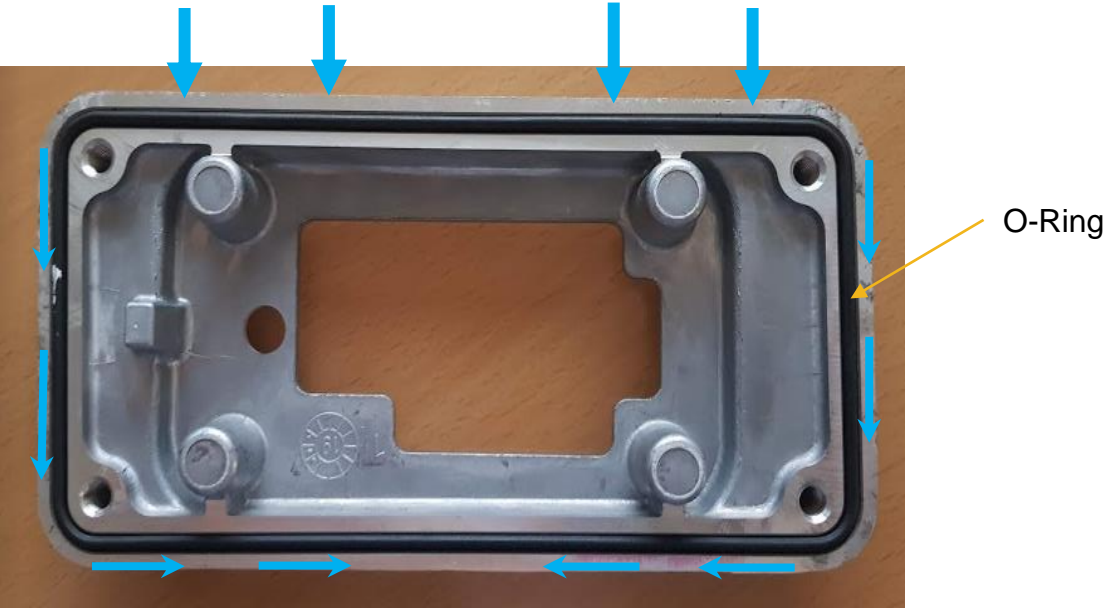
EXAMPLE 1: RESS CONNECTOR BLOCK

Block Material: A380

Connector: Plastic

Tray: Elpo Coated Steel

Connector and block are located underbody and exposed to salt water that is wicking into the gaps between the components.

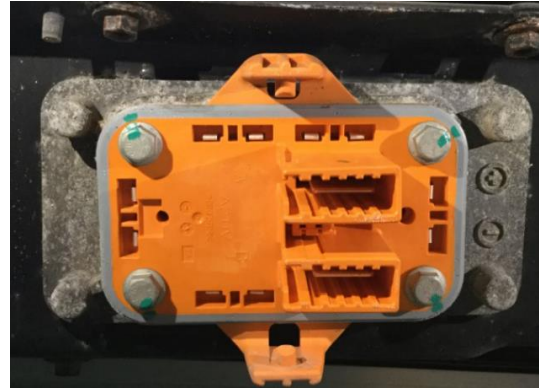
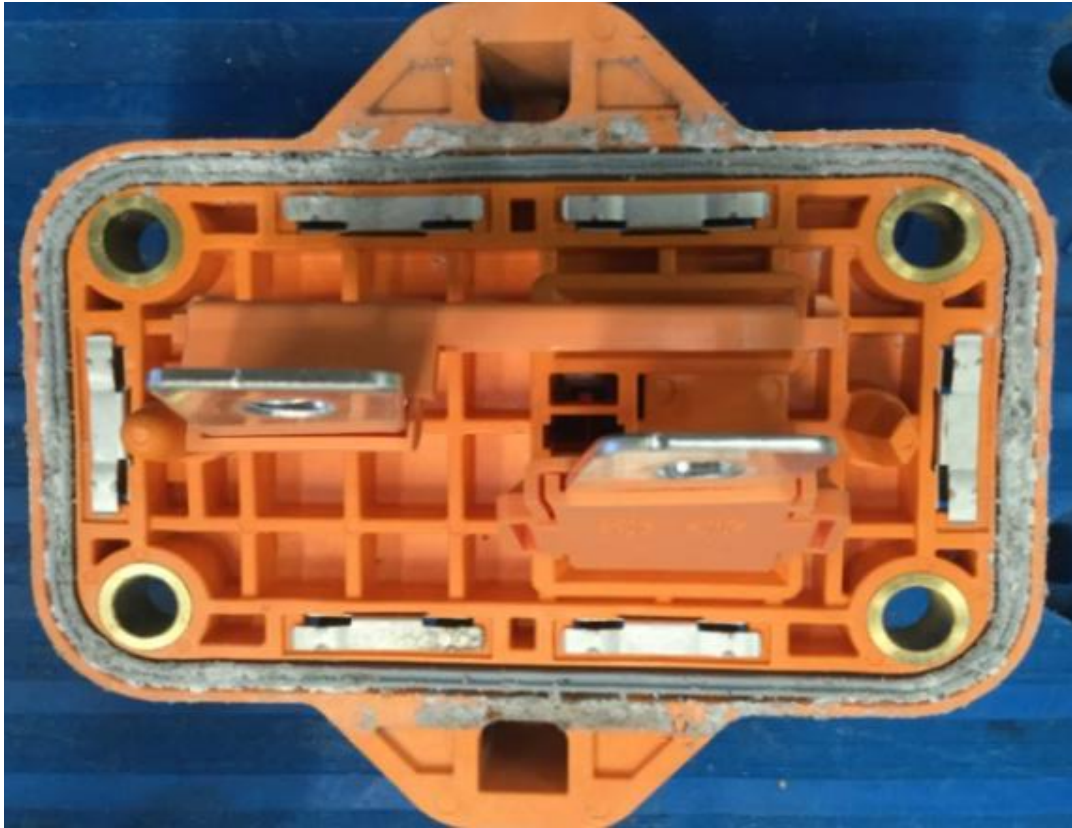
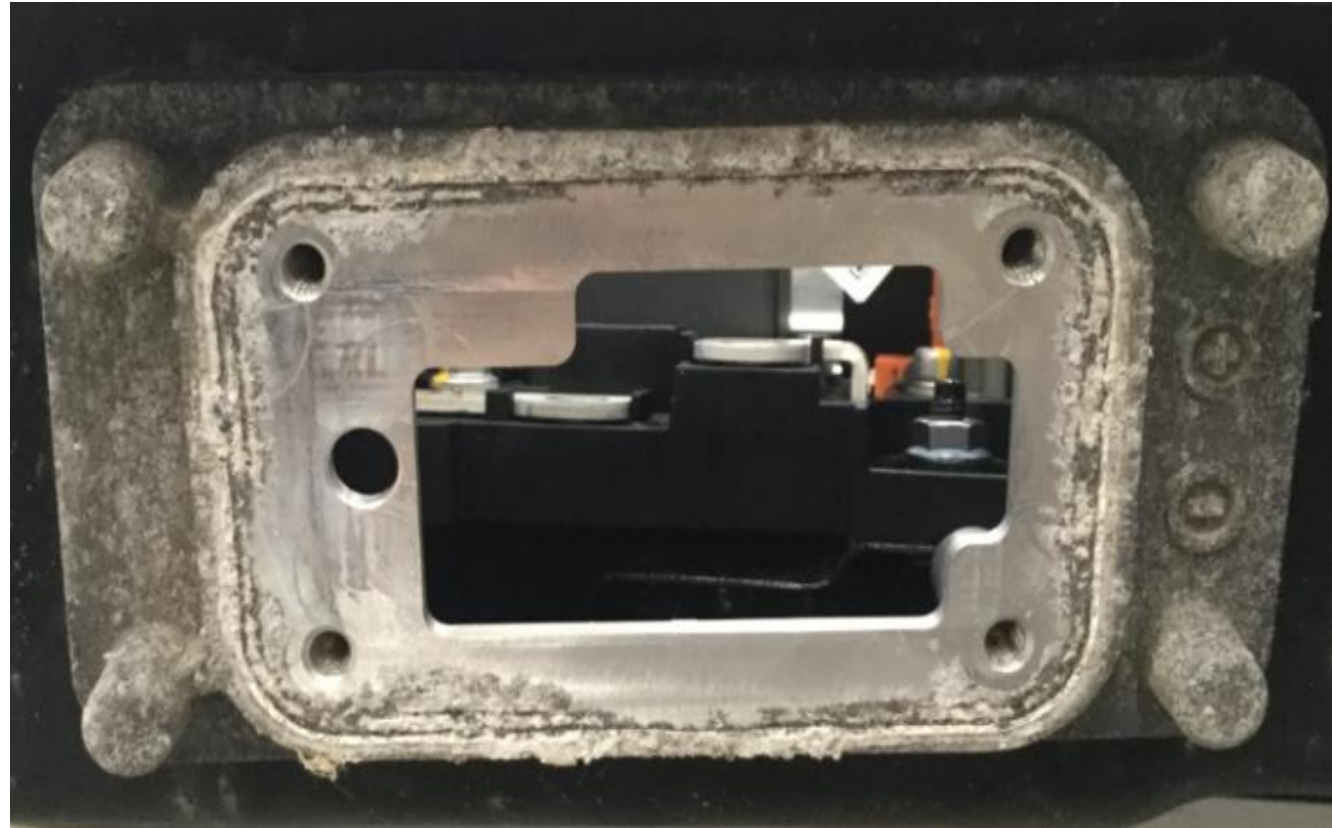
EXAMPLE 1: BATTERY PACK CONNECTOR BLOCK

Issue one: Corrosion has penetrated past the primary seal of the orange connector and entered the inside of the Battery Enclosure.

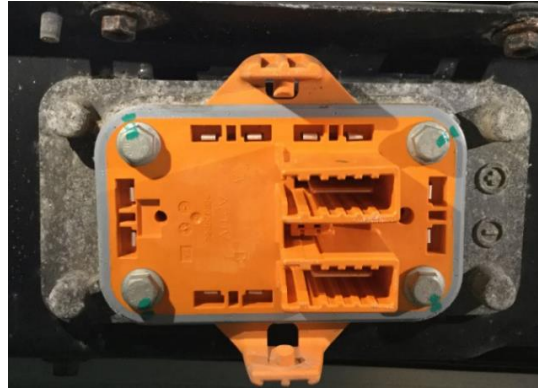
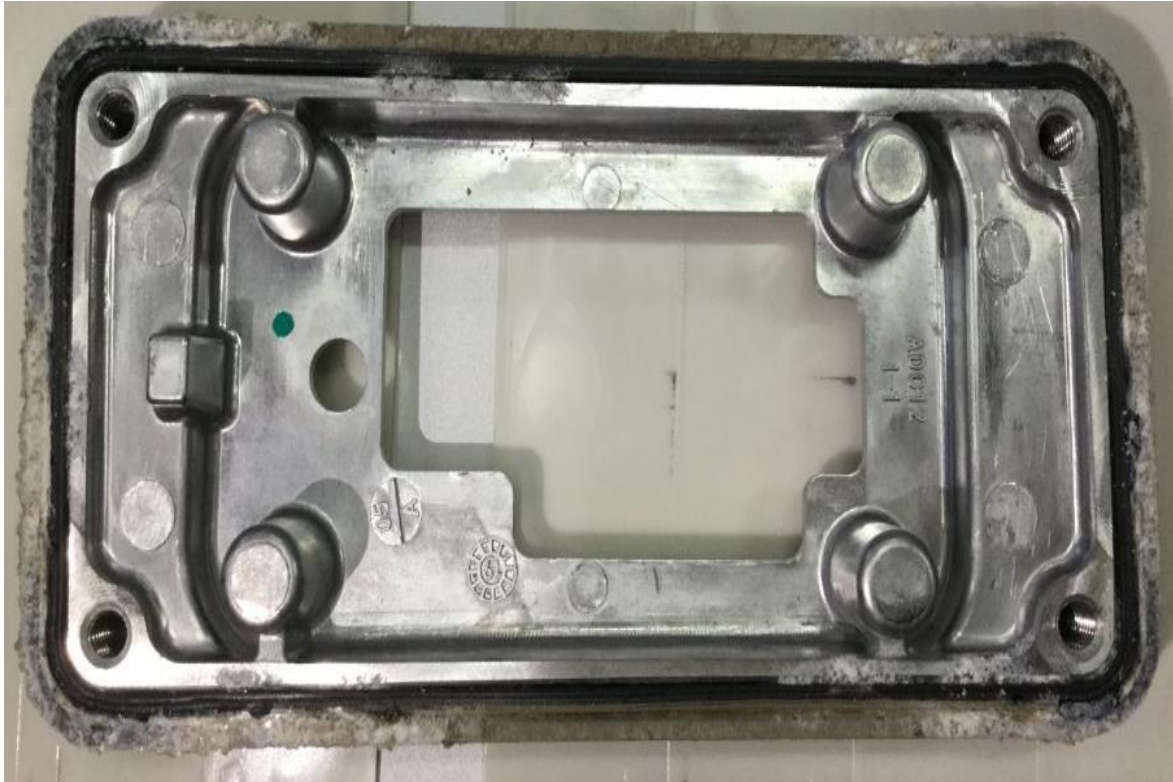
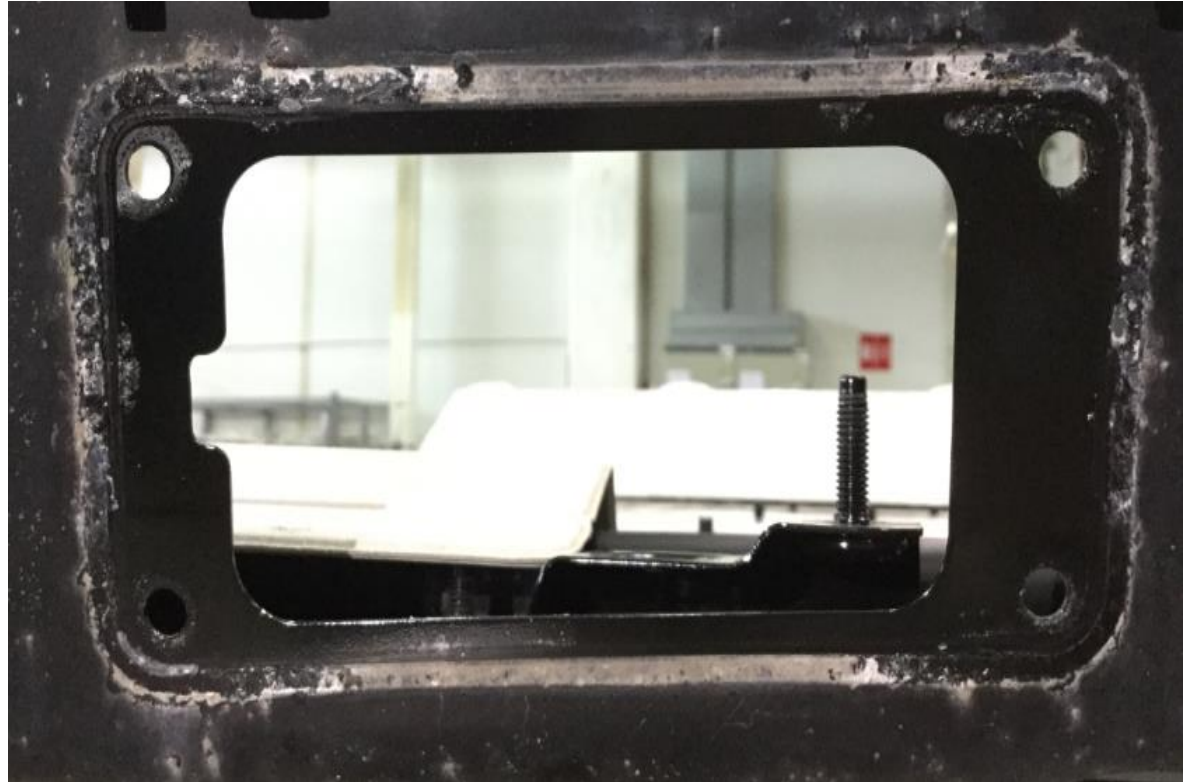
EXAMPLE 1: BATTERY PACK CONNECTOR BLOCK

Issue two: Leak through the primary seal of the connector back plate.

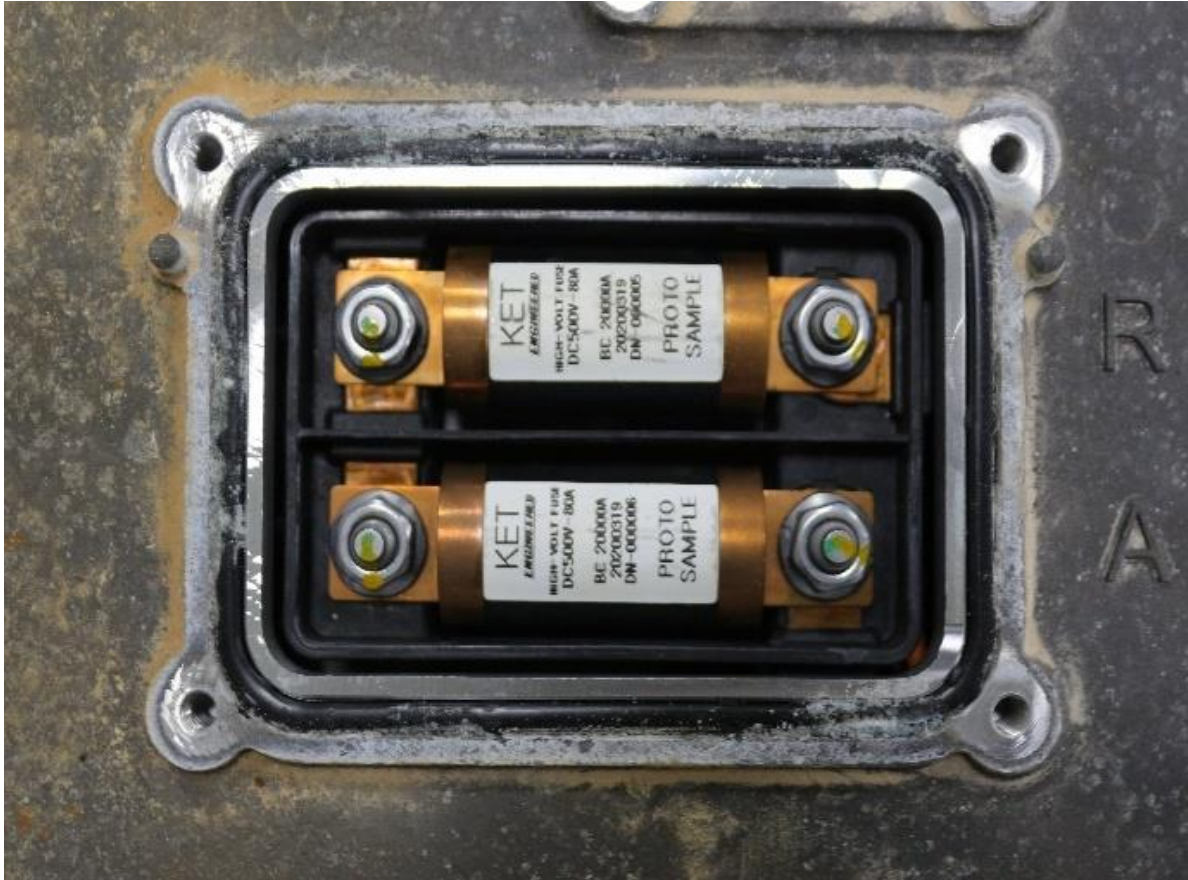
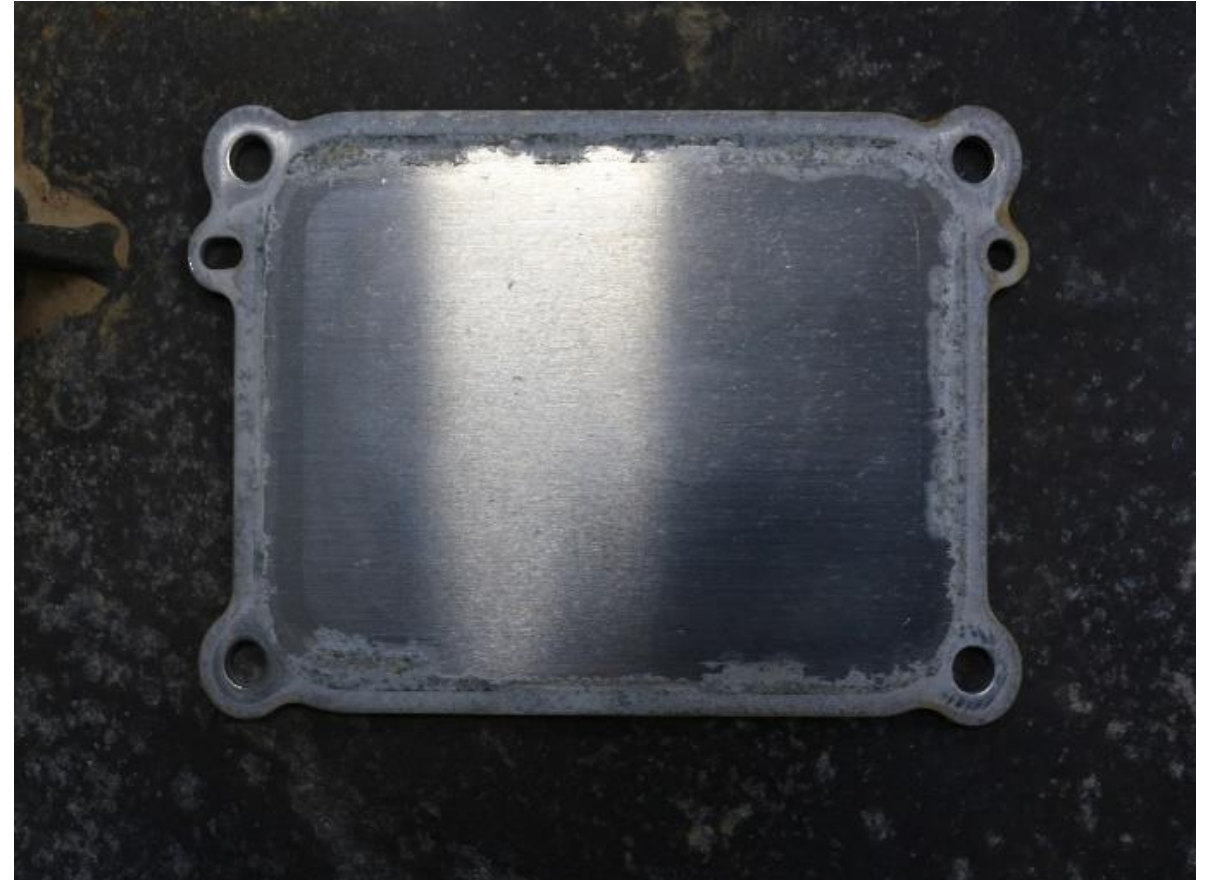
Example 2: IPE (Integrated Power Electronics)- Cast Aluminum Housing (A380) Interfaces to

a) DC Fuse Cover (Aluminum)

b) HVAC Connector (Plastic)

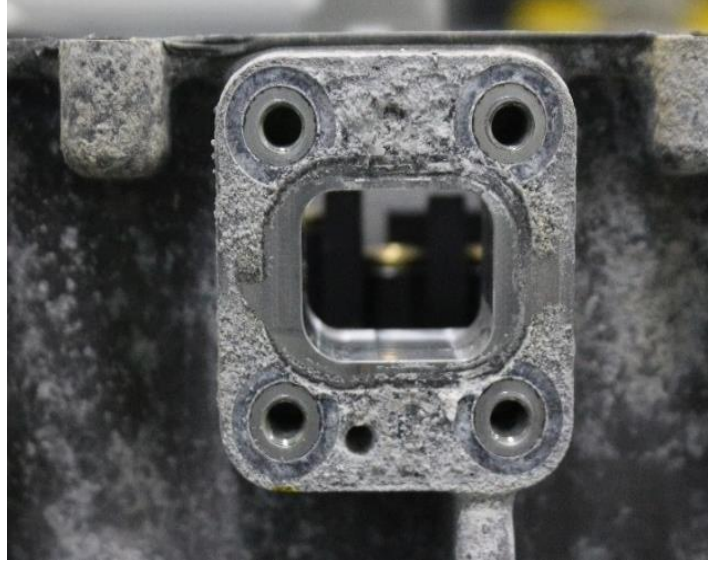
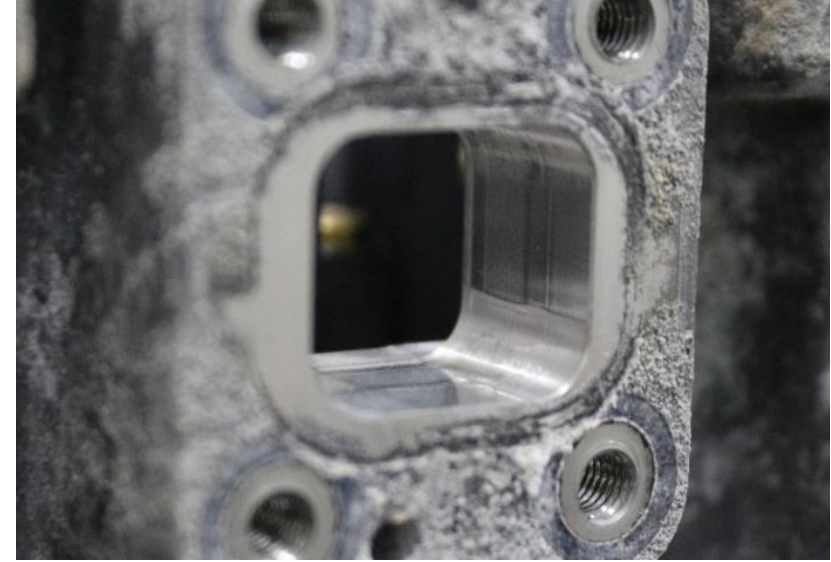
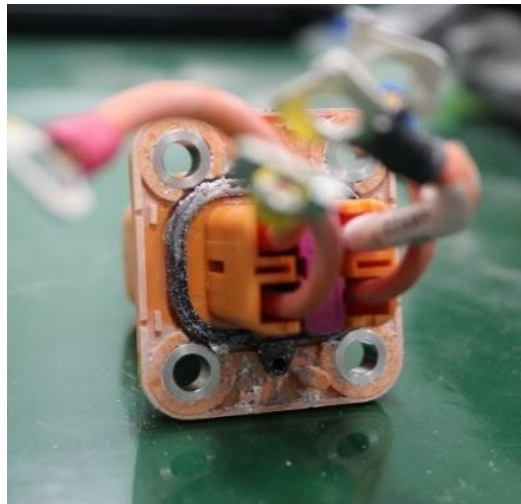
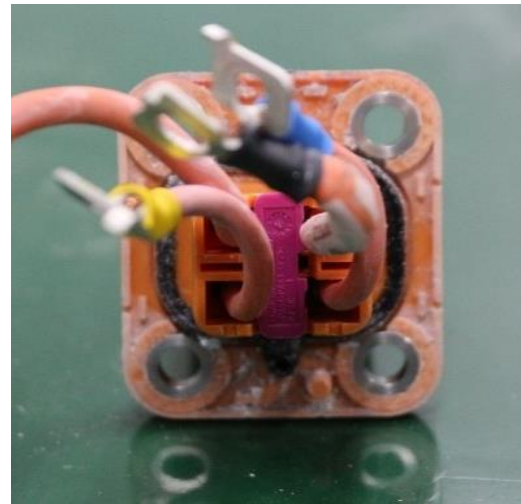
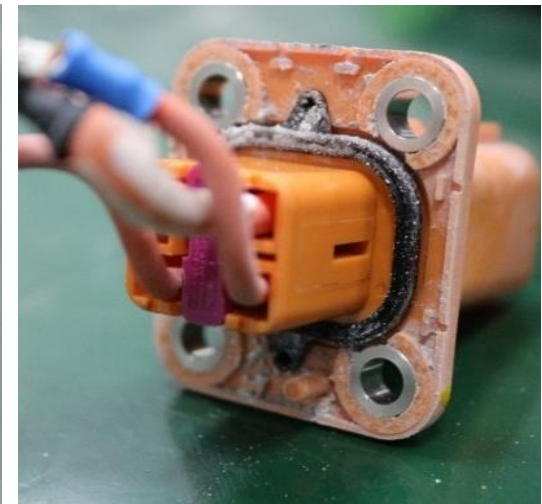
Example 2: IPE (Integrated Power Electronics) - Cast Aluminum Housing Interfaces to

a) DC Fuse Cover (Aluminum)

b) HVAC Connector (Plastic)

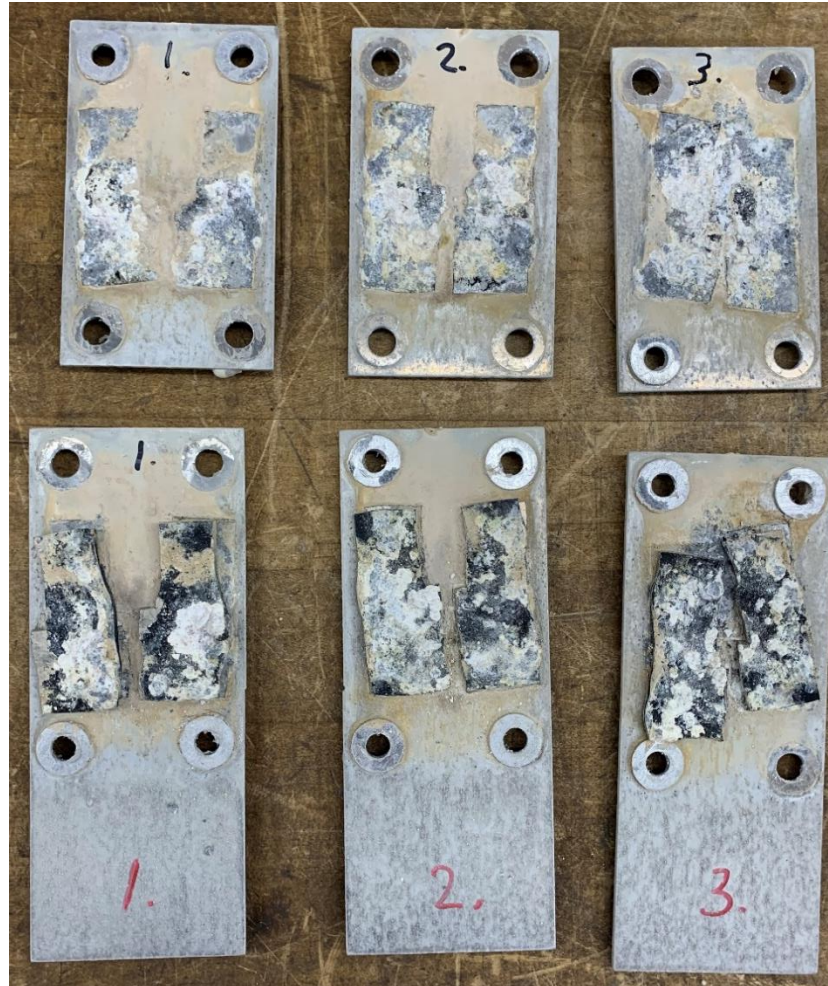
GALVANIC CORROSION CAUSED BY CONDUCTIVE ELASTOMERS

CONDUCTIVE ($< 10E4 \Omega\text{CM}$)

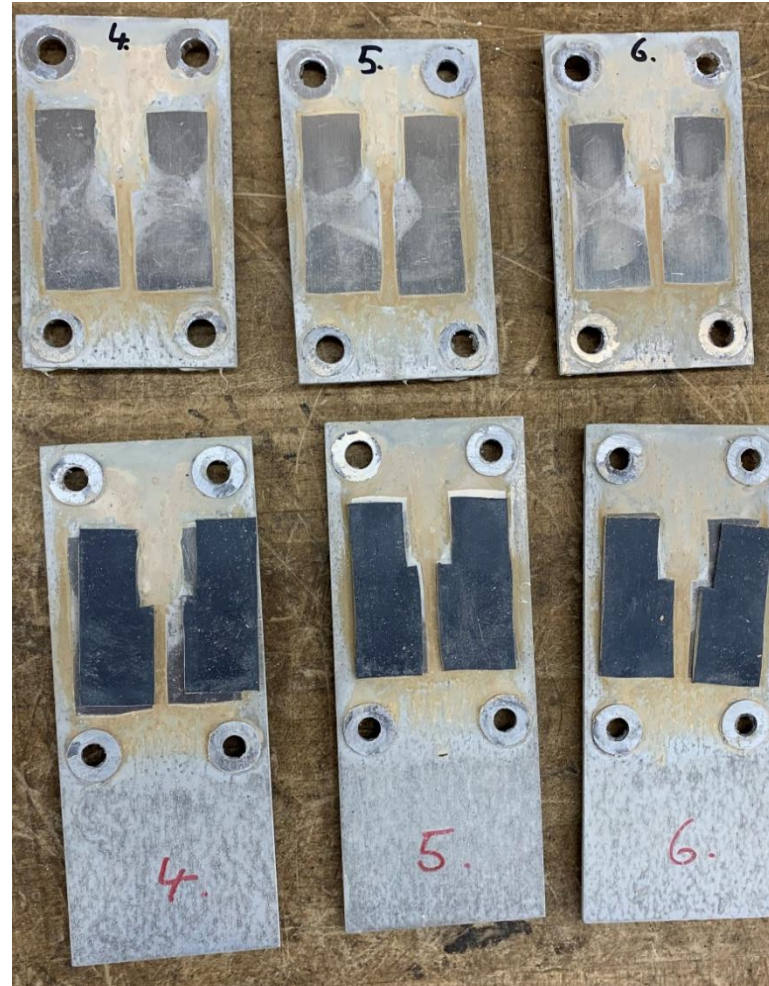
NON-CONDUCTIVE $> 10E11 \Omega\text{CM}$

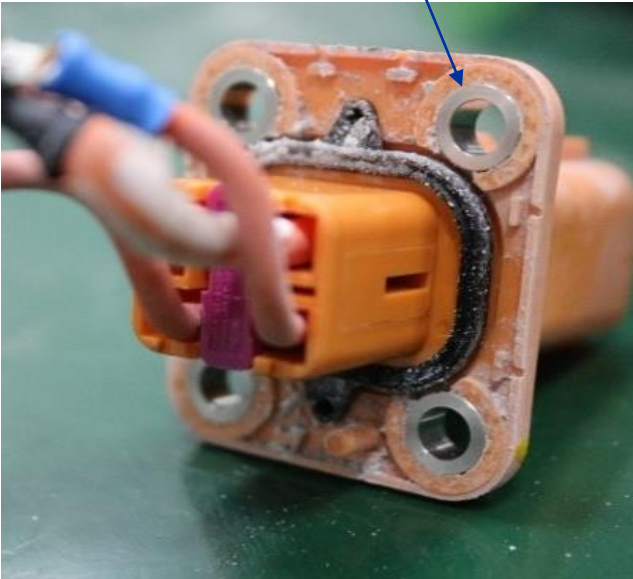
GALVANIC CORROSION CAUSED BY STAINLESS STEEL BUSHING

Stainless Steel Bushings

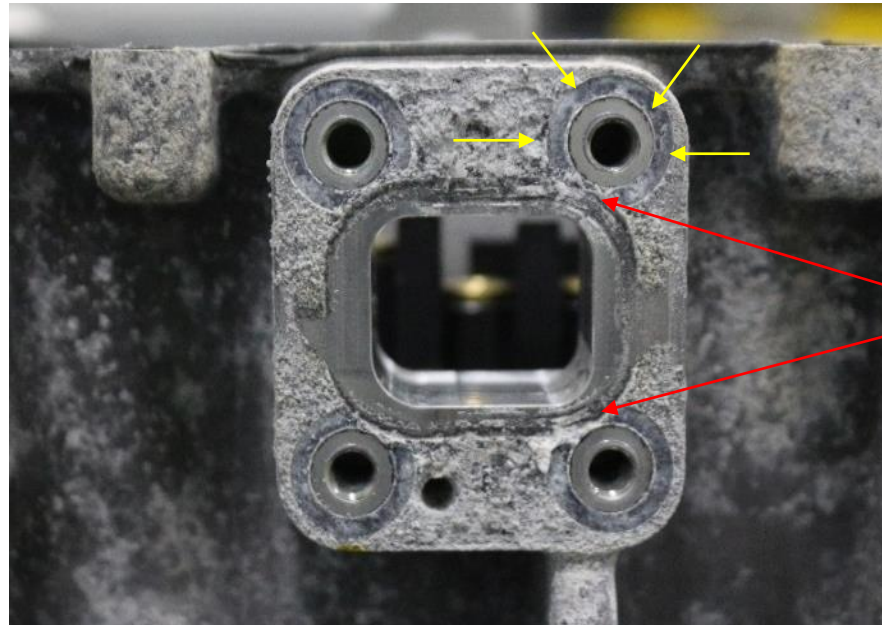
Galvanic corrosion appears around edge of bushing
(causes “raised surface” which reduces seal compression)

Highest corrosion observed
at corners near bushing
locations.

- Liquid Applied Sealer (RTV). Although RTVs, continuous welds, and other methods for continuously sealing a crevice might be effective, not all components can realistically have these kinds of sealing methods (e.g. serviceable covers or connectors).
- Bushings: Stainless steel and brass can cause galvanic corrosion. Use coated steel or Aluminum.
- Add protective coating to housing and cover. Coatings like anodization bring significant improvements. Might have to add laser etching process after anodizing for electrical grounding.
- Isolation Film (Polyurethane).

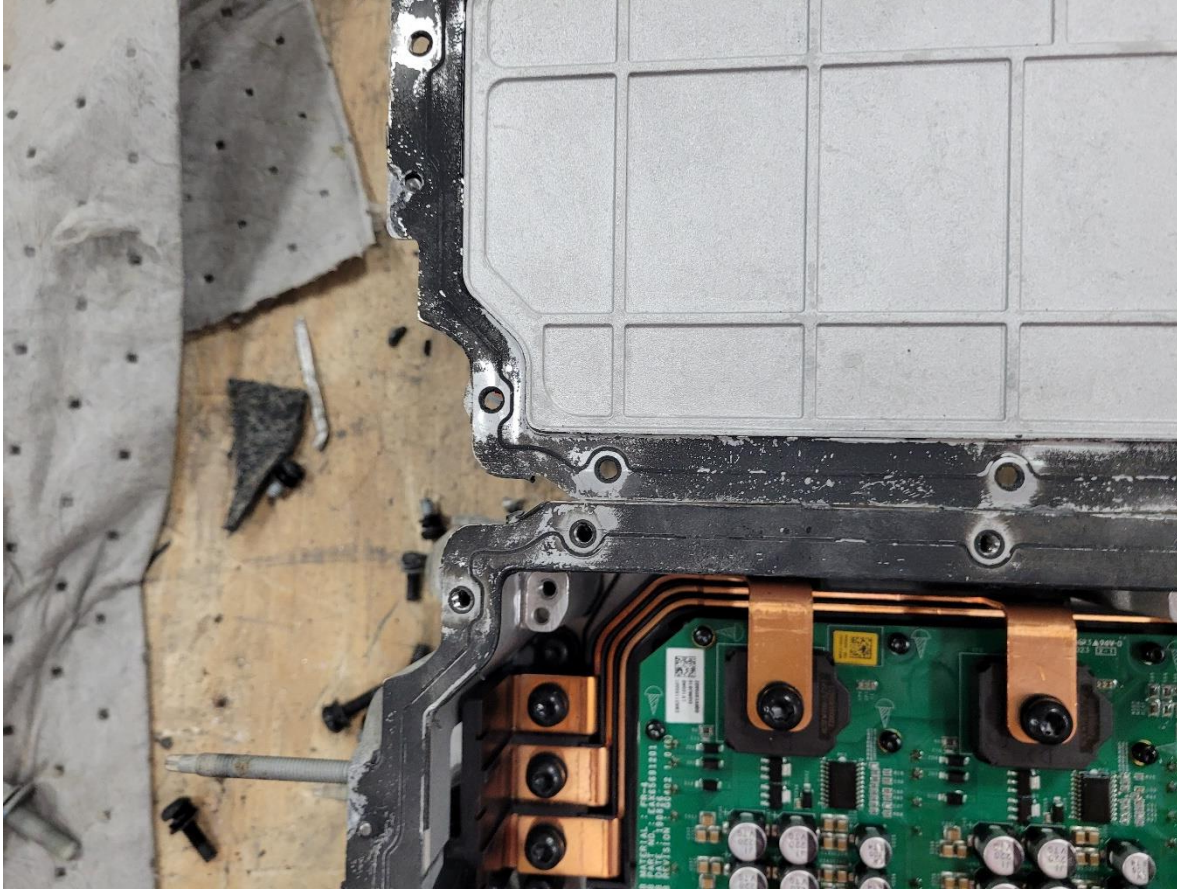
RTV SEAL - EXAMPLE

This sealing concept utilizes RTV liquid applied sealer on cover plates vs metal/rubber gasket.

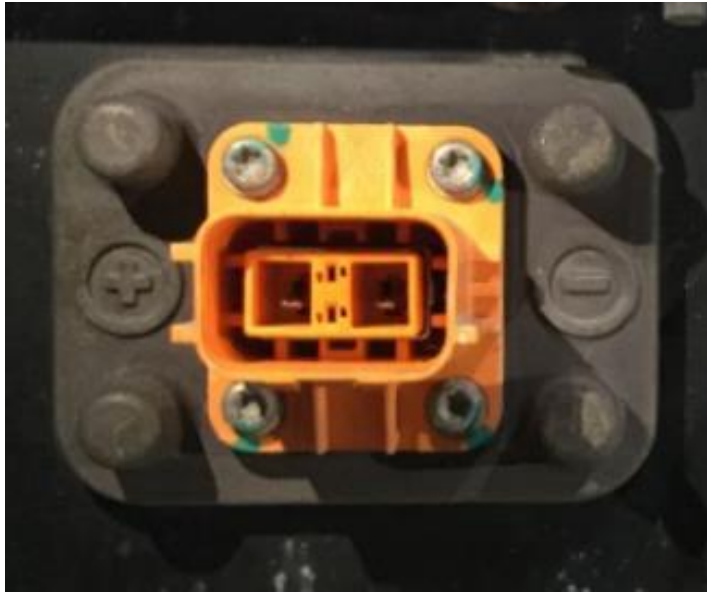
X3 Connector with Anodization

Block Material: A380

Connector: Plastic

Tray: Elpo Coated Steel

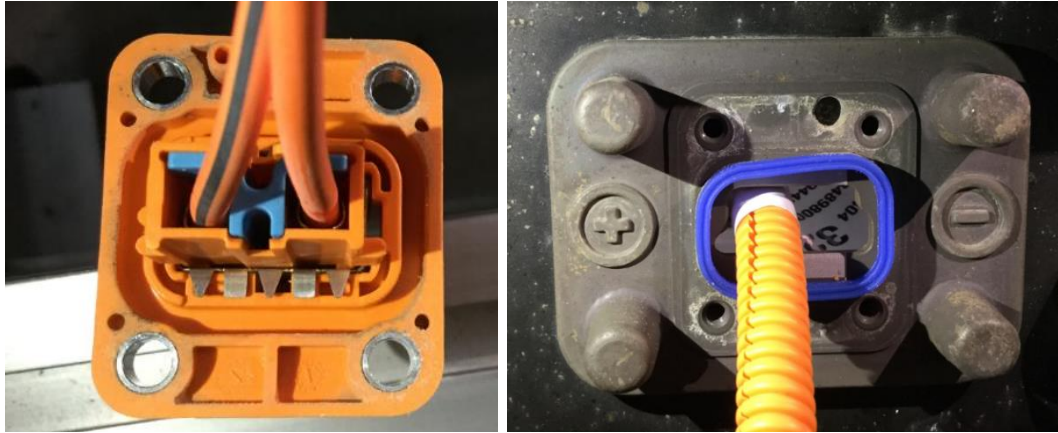
X3 Connector with Anodization

Front

No significant corrosion on anodized block

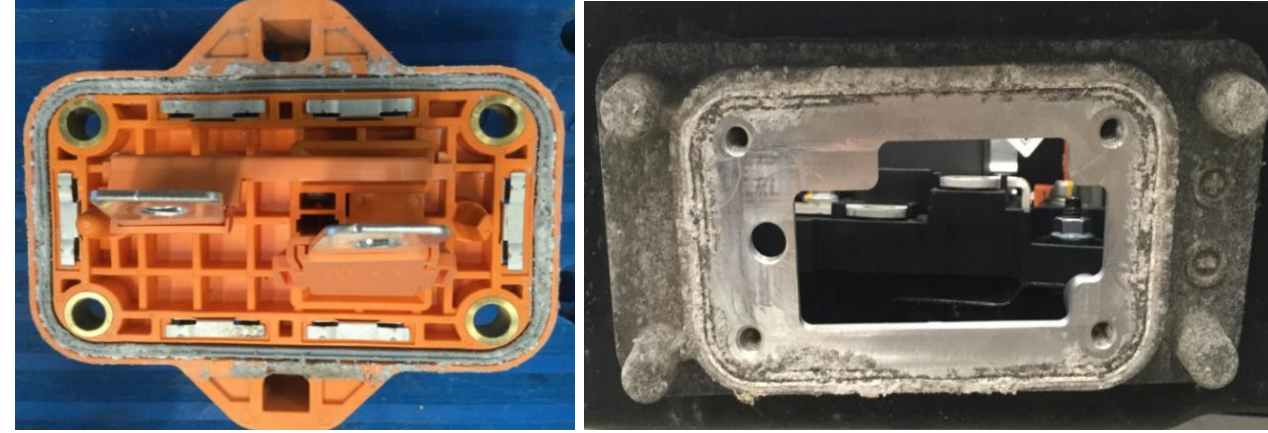
X4 Connector without Anodization

Back

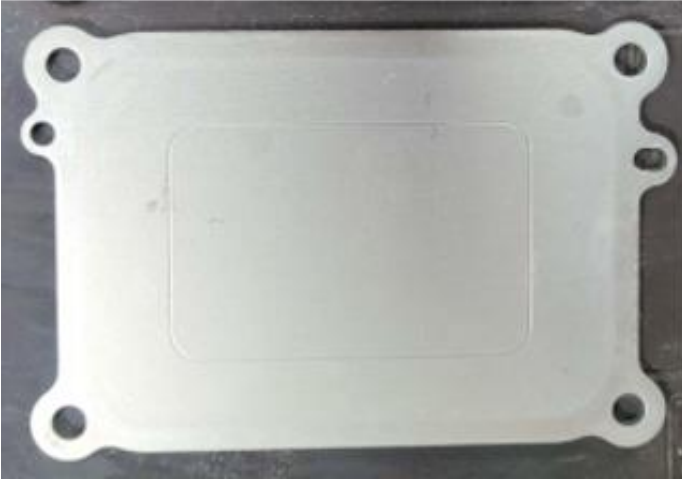
Fuse Service Cover

With Anodization

No significant corrosion on anodized parts
