# EPRI Corrosion Study in Northern California Setting

## Coupon Testing of Multiple Alloys at The Geysers

Andrew Coleman, Ph.D., EPRI, Palo Alto, CA

Originally Presented at Geothermal Research Society Meeting, Kumamoto Japan

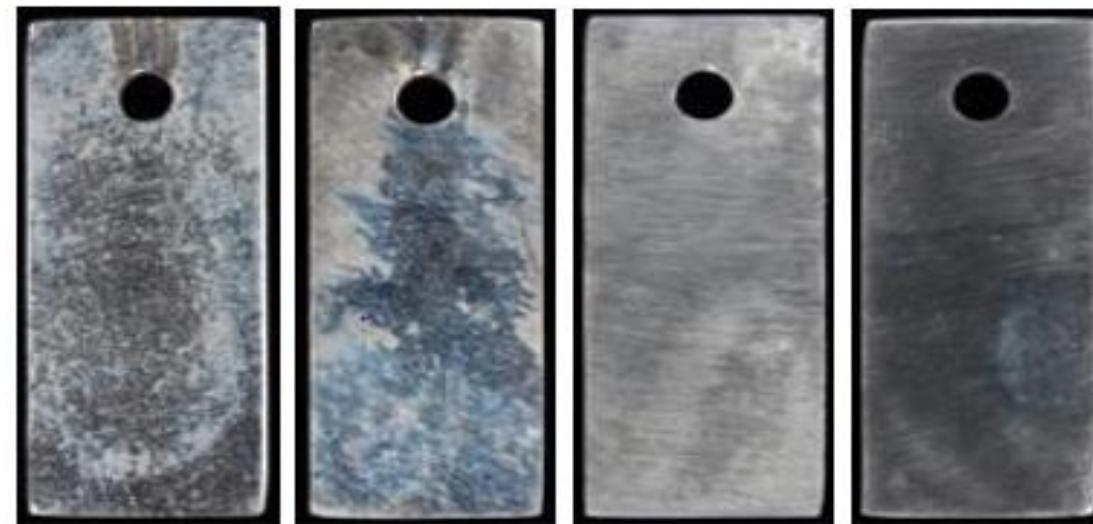
- **Coupon Testing**

- High temperature coupon testing with geothermal fluids at site specific locations

- General corrosion rates
- Onset of localized corrosion (SCC and Pitting)
- Effect of fluid flow velocity

Bassler et al. "Materials Evaluation for Geothermal Applications." 2015
