# Addressing Failures in Molten Salt Thermal Energy Storage Tank for Central Receiver Concentrating Solar Power Plants

6th Thermal-Mechanical- Chemical Energy  
Storage Workshop

NREL/PR-5700-90714

Project 38475 – “Failure Analysis of Molten salt Thermal energy storage tanks for in-service CSP plant”

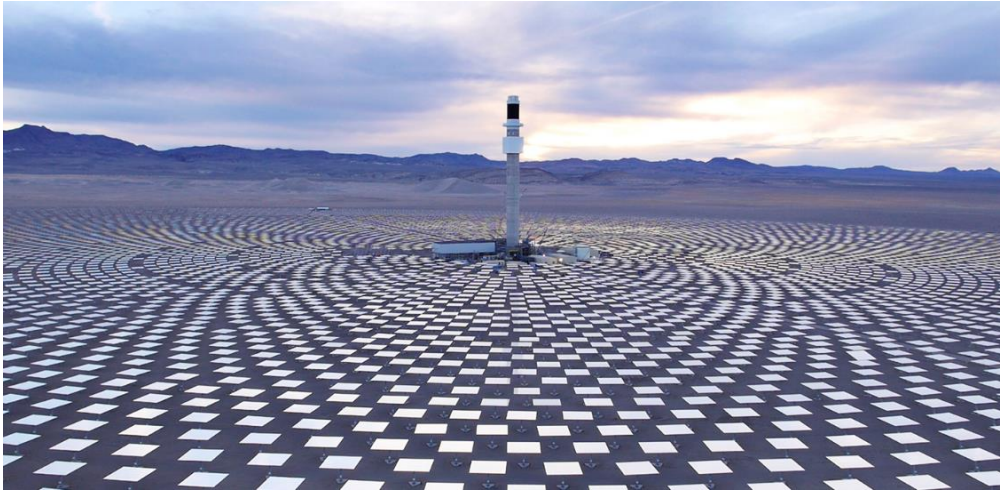
[Crescent Dunes CSP Plant, Tonopah, NV]

Several Failures have occurred in molten salt tanks in commercial CSP Plants around the world
