Use of laboratory accelerated cyclic corrosion test for predicting on-road corrosion behavior of AA6xxx coupled to carbon fiber reinforced plastics

Priyanka Adapala, Dr. Gerald S. Frankel

Fontana Corrosion Center

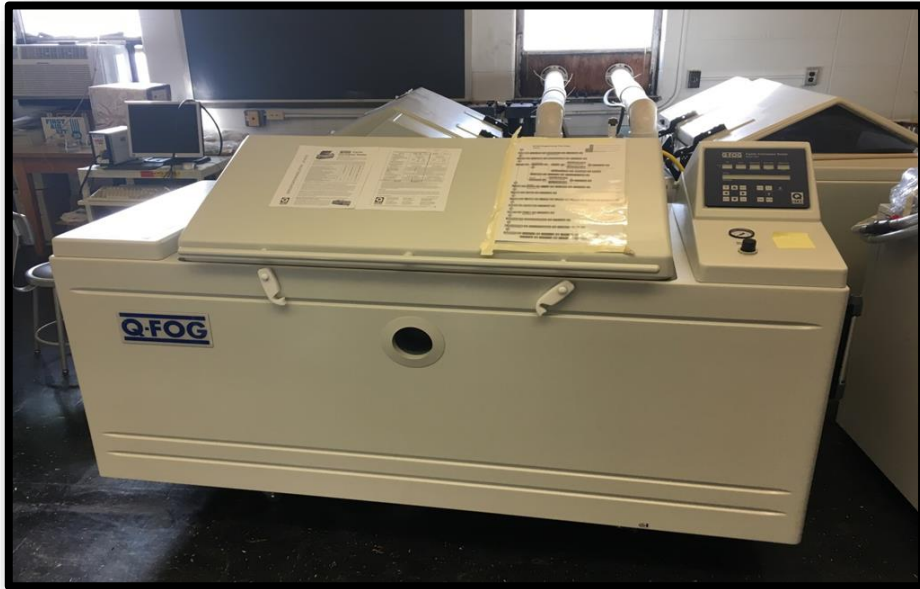
Controlled Relative Humidity Cyclic Corrosion Tester, facility at FCC

- ❖ Designed by Ford Motor Company
- ❖ Used to study conditions such as salt load/climatic variations during in-service exposure.
- ❖ Solution used was 0.5 wt.% NaCl.

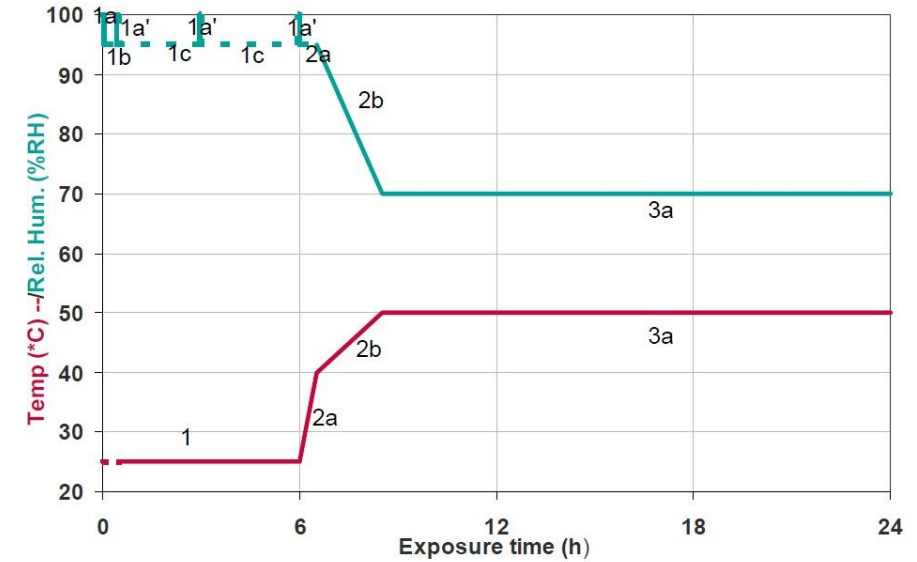
Workday (Mon-Friday) test cycle.

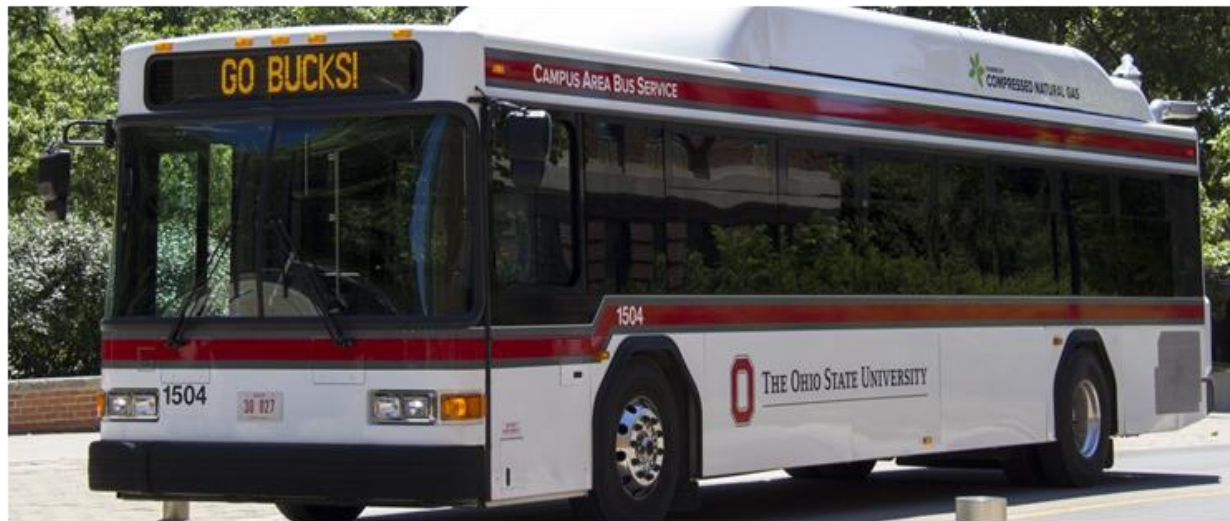
OSU bus onto which materials were mounted

- ❖ To understand the corrosion behavior of CFRP-AA materials under natural road conditions including de-icing salts during winter, mud and other environmental pollutants and varying weather conditions.
- ❖ Materials were fixed onto the undersides of busses that circulated the campus for 1 year.

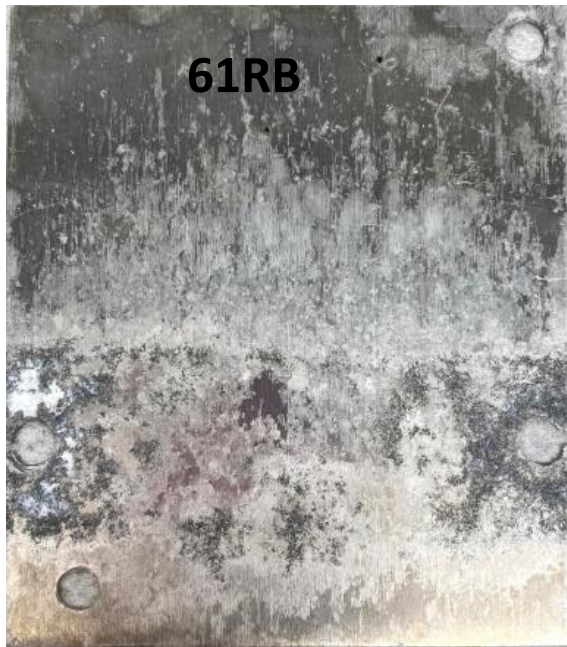
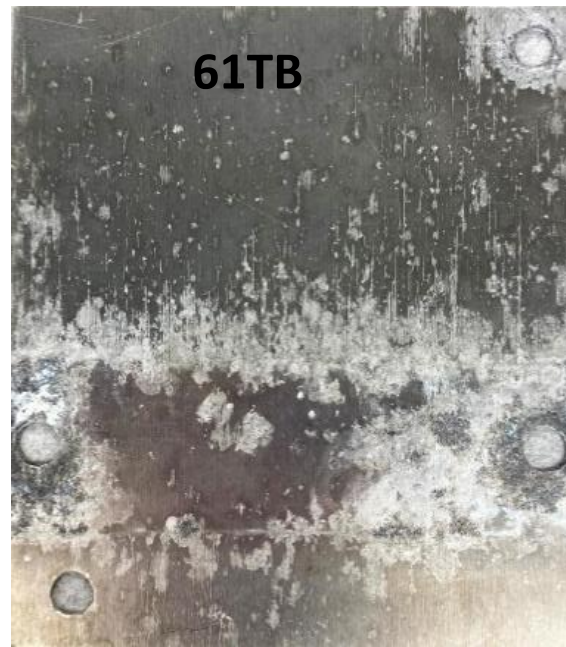
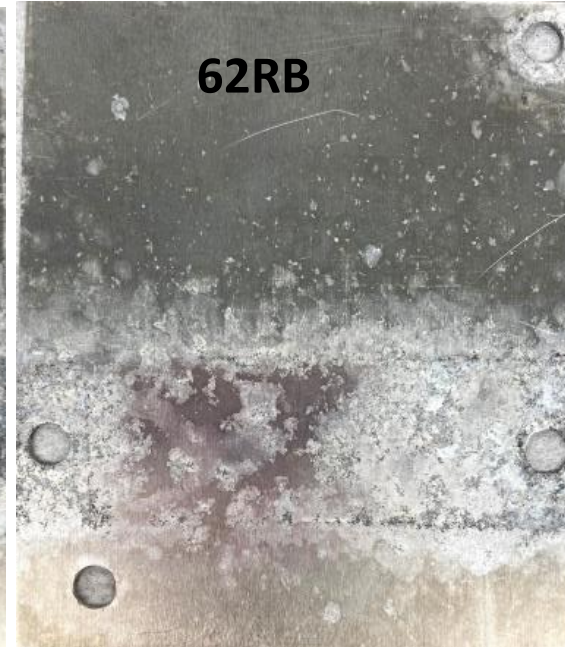
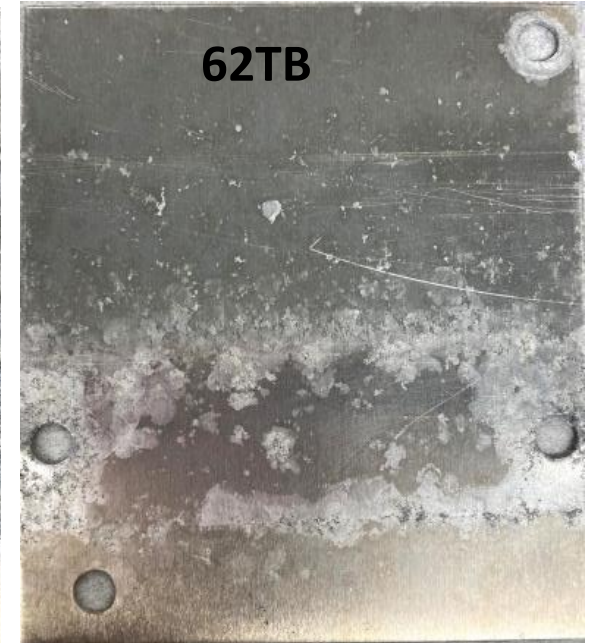
Visual Inspection of On-bus tested Coupons

- ❖ Visual inspection of coupons depict **highest** extent of corrosion on **61RB** whereas **lowest** on **62TB**.
- ❖ Trend in corrosion susceptibilities among other coupons isn't clear.

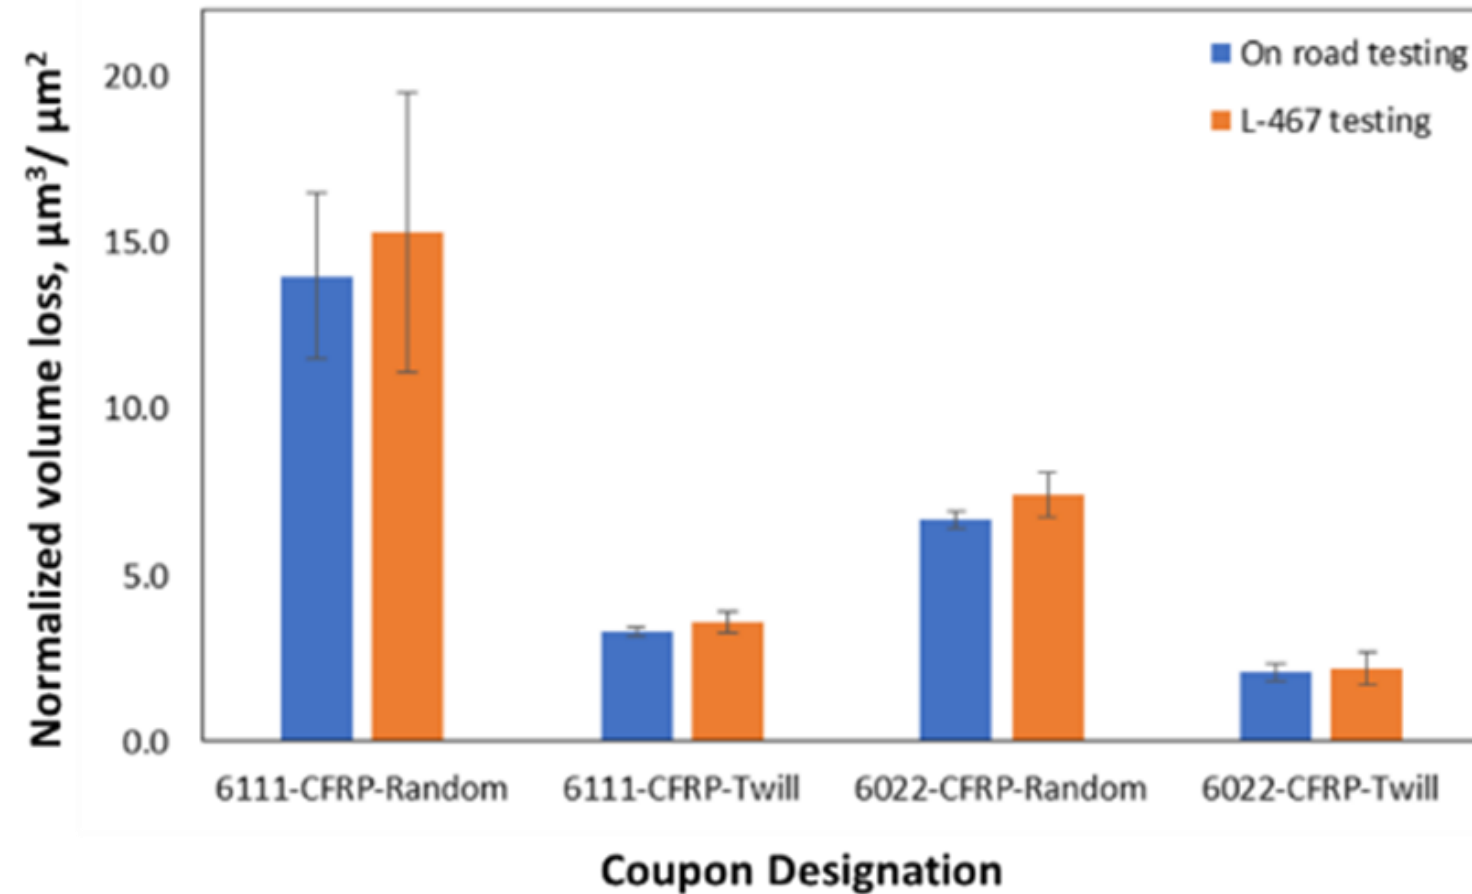
Summary of OP analysis

- Volume losses of AA panels coupled with CFRP-Random are higher than CFRP-Twill.
- AA6111 exhibited larger extent of corrosion than AA6022.
- More corrosion was observed in coupons subjected to L-467 testing than on-bus testing.
- Order of corrosion attack: 61R > 62R > 61T > 62T in both the tests.
